Navajo Abandoned Uranium Mine

Site Screen Report

Evans Huskon No. 34 AUM Site

January 2011

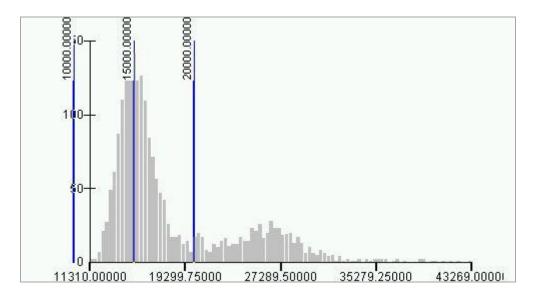
Distribution Chart and Statistics:

The following chart and statistics were generated by ESRI ArcGIS 9.3.1, and show the general distribution of the site gamma radiation measurements. The horizontal X axis represents the gamma radiation reading levels in cpm (lowest levels to the left). The vertical Y axis represents the frequency of each gamma radiation level.

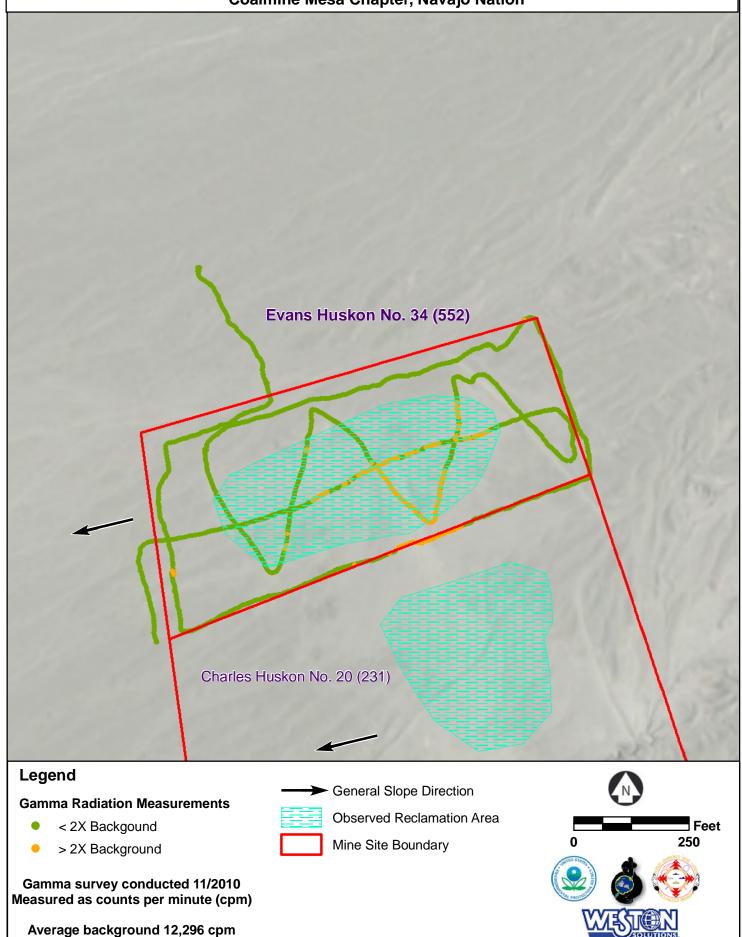
Figure 1 - Gamma Radiation Measurements, Above Two Times Background
Evans Huskon No. 34 (552)
Coalmine Mesa Chapter, Navajo Nation

A total of 2,100 gamma radiation measurements were collected from the mine site, ranging from 11,310 cpm to 43,269 cpm. The measurements collected at the reclamation cap were found at a maximum level of approximately 40,000 cpm. The measurements are represented in Figures 1 and 2.

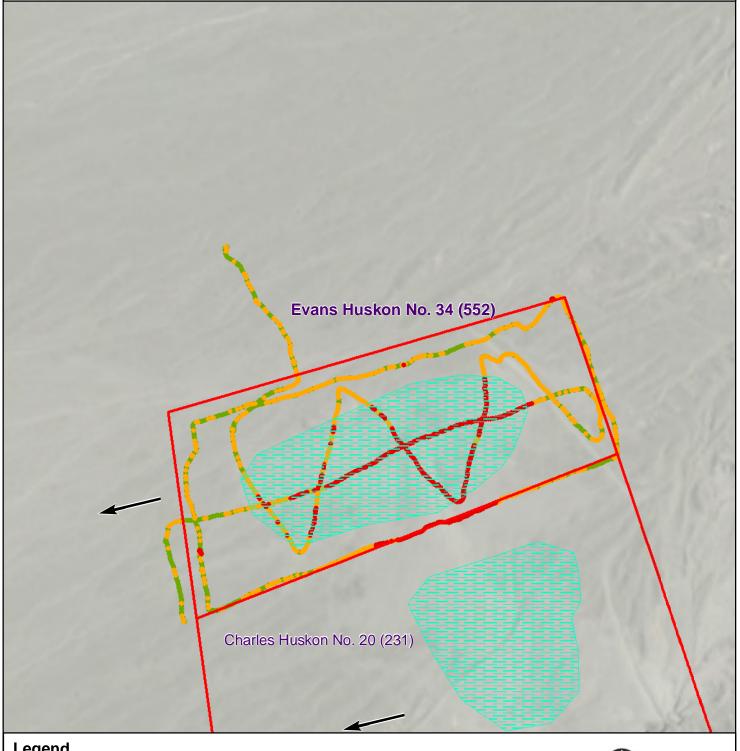
Figure 2 - Gamma Radiation Measurements Evans Huskon No. 34 (552) **Coalmine Mesa Chapter, Navajo Nation**

Gamma survey conducted 11/2010 Measured as counts per minute (cpm)

Average background 12,296 cpm
